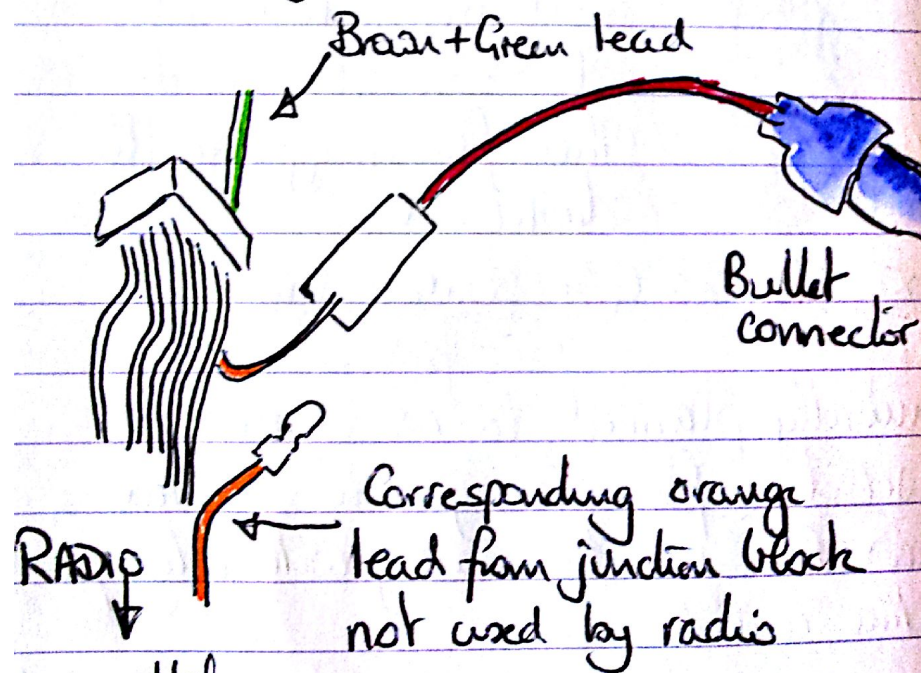
So used it to run a lead to the light bulbs wired in

parallel. I checked at each stage that there was power to the connectors. All connectors properly crimped with wire tinned first with soldering iron

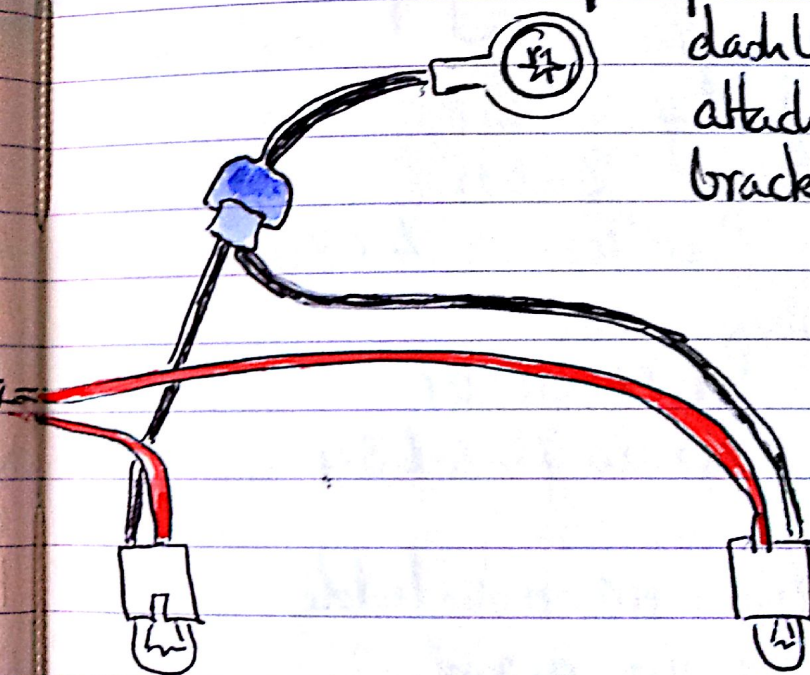
earthing point found where dashboard attaches to bracket

So all put back together & radio still works, and the dashboard lights too! Have not checked to see if the thermostat works.
